# The Australian Health Surveyor

# Septic Tanks Revisited . . .

## Success or Failure of On-site Effluent Disposal

# The Hydrology of on-site Septic Tank Effluent Disposal on a Yellow Duplex Soil

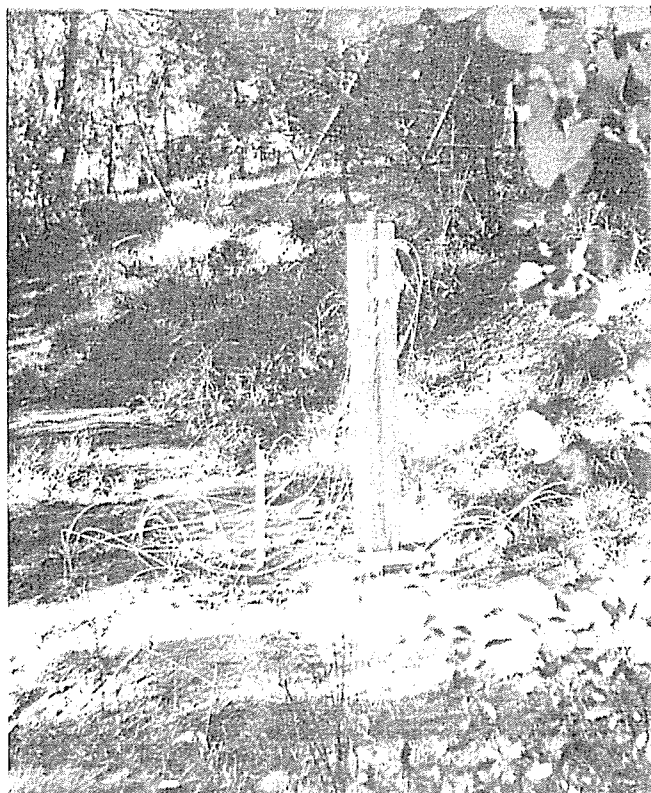
Fig 6. Absorption trench monitoring assembly at Eltham.

Smaller sets of tensiometers were installed at the other disposal systems investigated. In Eltham (Fig 6)

there was one set on each of the three trenches, and in Kinglake where there was only one trench, one set was positioned near the beginning and one set at the end of the trench.
