Case Studies of Mound Systems

Centre for Environmental Training

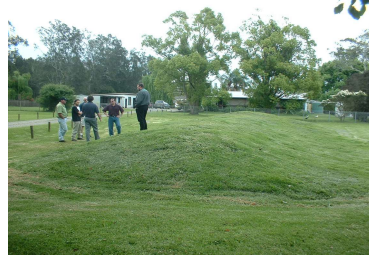
Completed Wisconsin Mound

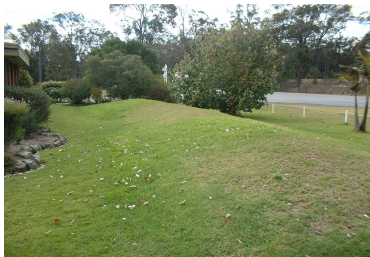
Completed Wisconsin Mound

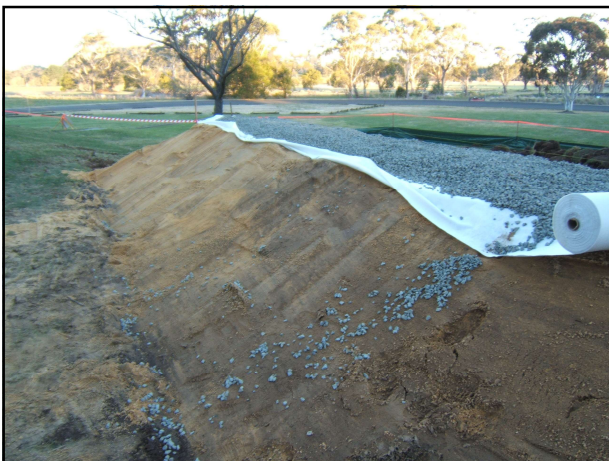
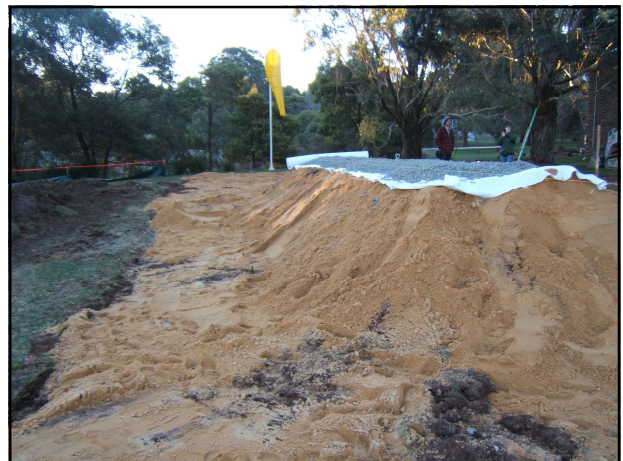
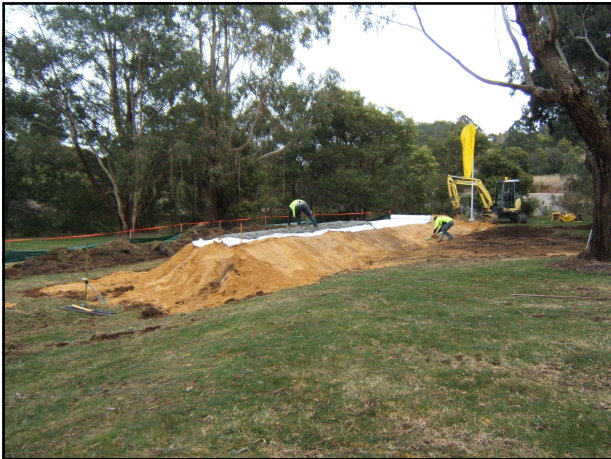
Burrawang Mound Construction

- Construction issue
- Installers claimed to have installed several mounds previously
- Were reluctant to put vegetation on top of mound
- Were adamant that in previous mounds with turf cover there had been seepage from the mound at a high level on the mound flanks
- But did not really know the cause of this!

Burrawang Mound Construction

- So what was wrong?
- This mound was to receive primary treated effluent
- What was a likely outcome following this installation?
- What rectification was required?
- Experienced installers are critical, as is communication between the designer and installer at installation stage
- When should the regulator inspect the installation?

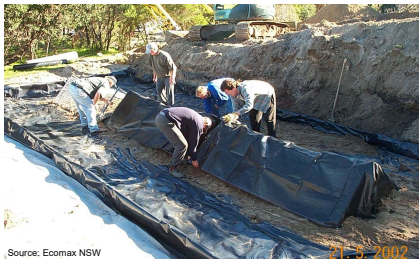
Ecomax Design Failure

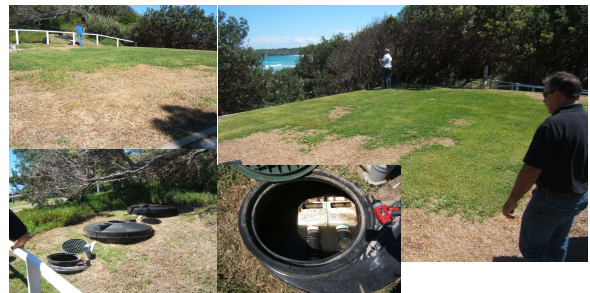
Flout dosing a sand filter replacing failed mound

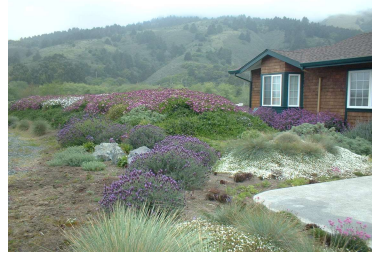
Alternative Vegetation Cover
