THE PACIFIC ISLAND COMPOST TOILET

Michelle Maher & Terry Lustig
Environmental Management Pty Ltd

Abstract

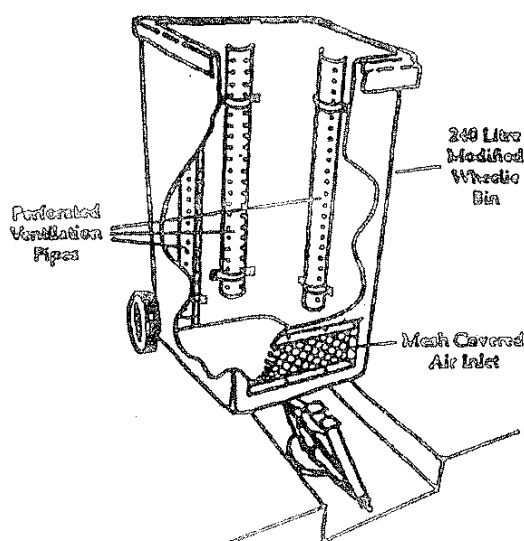
Figure 3: Detail of Wheelie-Bin

This style of composting toilet was developed by Dr Leonie Crennan and has been used successfully in Australia. Wheelie-bins are modified with interior pipes to assist aeration, and are placed under a pedestal and connected to an excess liquid trench, as shown in Figure 3. When full, the wheelie-bin is detached from the trench and placed in the sun, and a new bin is placed under the pedestal. There were eight wheelie-bin composting toilets constructed in the trial, with one of these eight shown in Photo 1.

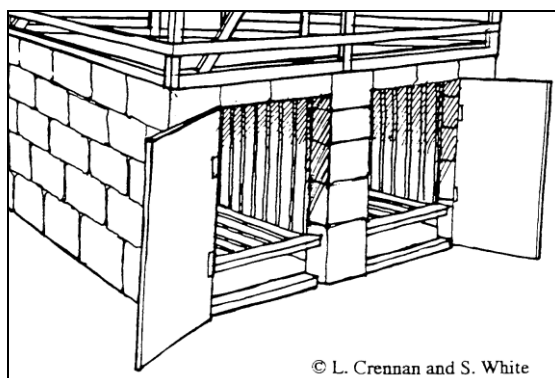
Figure 4 Detail of Cage-Batch – Concrete Bricks instead of Marine Ply

This style of composting toilet had two vaults, with the interior made of a galvanised mesh cage to aid air circulation, as shown in Figure 4. Both the wheelie-bin and cage-batch had superstructures of marine ply. Four cage-batch composting toilets were constructed in the trial, with one shown in Photo 2.

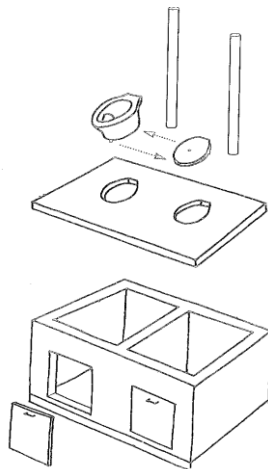
Figure 5 Detail of double-vault composting toilet

The double-vault composting toilet was built from locally available materials such as coconut thatching with a tray for aeration, as shown in Figure 5. Three double-vault composting toilets were built in the trial, with one shown in Photo 3.

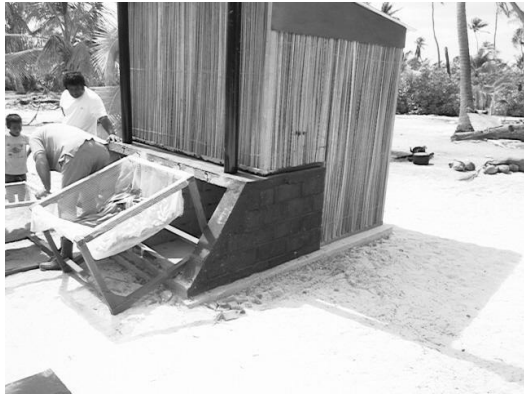
Photo 5 Net Composting Toilet

To ensure that the new design of composting toilets worked well, we designed two double-vault styles – the only difference being how they aerated the compost. One style used a tray and the other a net. The design was made robust, to allow that, as in Australia, tradesmen building the facilities *know* that they know better. As far as possible, the materials used were those readily available, such as coconut coir for sealing the hatches.

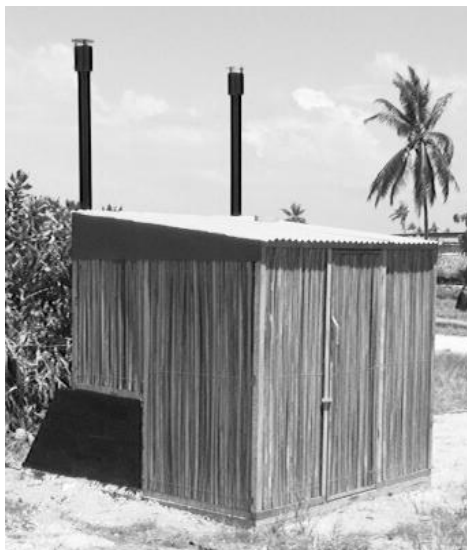
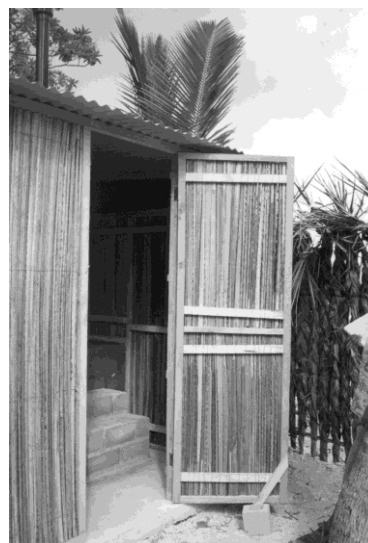
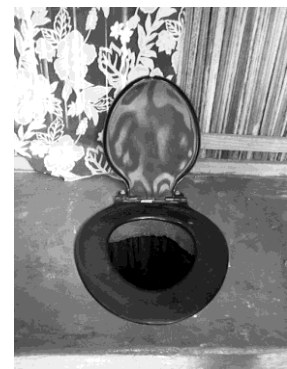
The vault is a sit-down model, which allowed people to squat and reduced the height of the building. The stairs were put inside the building, making it less obvious in the landscape. Coconut sticks were used for the exterior, in keeping with traditional I-Kiribati homes.

Photo 7 Views of Composting Toilet Showing (from left to right) Exterior of the Building, steps Inside Building and toilet Seat on Top of Vault.

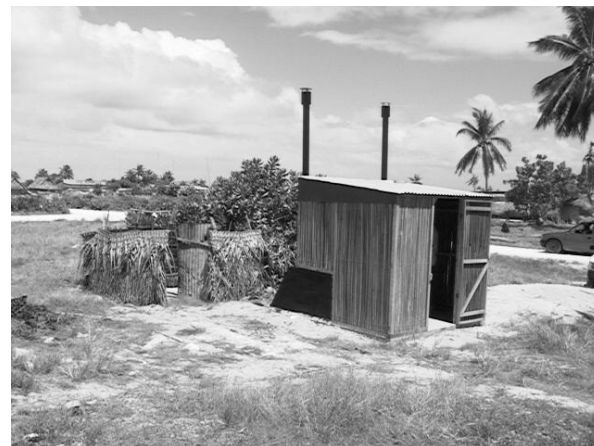
Photo 9 Composting Toilet with the Bathroom to Left of Toilet

As a result, more and more families are requesting the composting toilet, with the local doctor and leading Government of Kiribati personnel already having them on their land. As an example of this, Photo 9 shows a composting toilet with a bathroom placed right next to it. This bathroom and washing area would not be placed anywhere near smells or flies.
