## Inspection and Troubleshooting of On-site Wastewater Management Systems

### Inspection and Troubleshooting Scenarios II

## Scenario 1

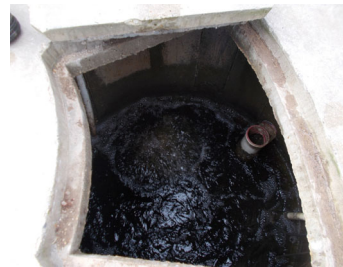
Figure 7: Aeration Chamber

- Figure 7 shows the aeration chamber. Figures 8 and 9 show the results of dissolved oxygen (DO) and pH tests.
- Comment on the performance of the aeration chamber.
- What adjustment to the aeration would you make as a result of your observations?

- Figures 2 & 3 – Lids might collapse. Ingress of water affects treatment. Broken bits of lid might fall in and cause damage.
- Figures 4 & 5 – Good crust, would expect anaerobic processes to operate satisfactorily
- Figure 6 – Minimal sludge; no need for pumpout.
- Figure 8 – DO 8-10mg/L is high, pH 7 is satisfactory. Could reasonably reduce the amount of air supplied. DO needs to be >2mg/L, but not too much higher.
- Figures 10 & 11. Clarification chamber clarity looks fair, but turbidity needs to be <5NTU for disinfection by chlorine and <1NTU for disinfection by UV, i.e. is not satisfactory.
- Low amount of food and high aeration and light brown colour indicates possible sludge loss (low F/M ratio)/carry over.
