Inspection and Troubleshooting of On-site Wastewater Management Systems

Inspection and Troubleshooting Scenarios I

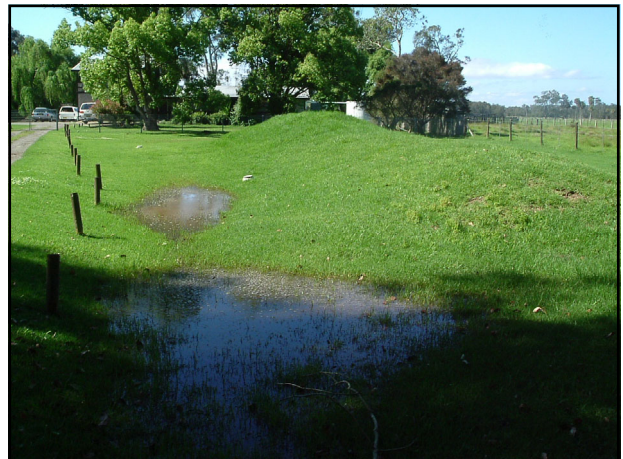
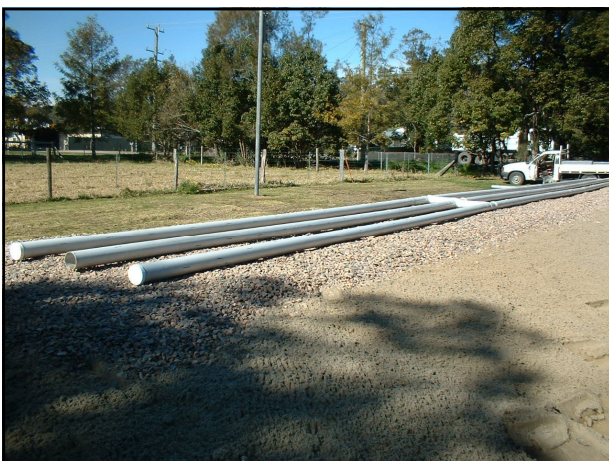
Scenario 1

- Wisconsin mound at a State government-owned house
- Look at the photo – is there a problem here?
- How would you determine if there was a failure in the:
 - Structural integrity of the mound;
 - The treatment process?

- What investigations would you carry out to test for failure?
- If the ponding around the mound was effluent, how would you rectify the failure?

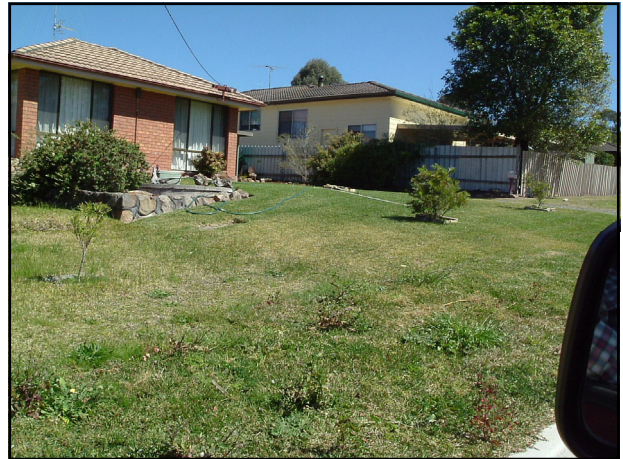
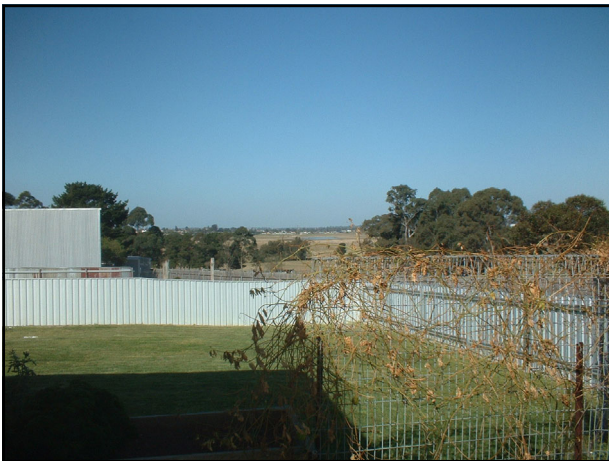
Scenario 2

- Aerated Wastewater Treatment System (AWTS) with single 5m 'spray bar'.
- Lot ~500m² within a rural village on the outskirts of Newcastle.
- There is no more than 30m² of suitable land application area in the front yard.
- 120m² available land application area in the back yard.

- Hydraulic balance requires a minimum irrigation area of 300m². Clearly not available.
- Would you consider requiring the installation of a pump out system? Why / why not?
- What other options are available to reduce the risk this system poses to public health and the environment?

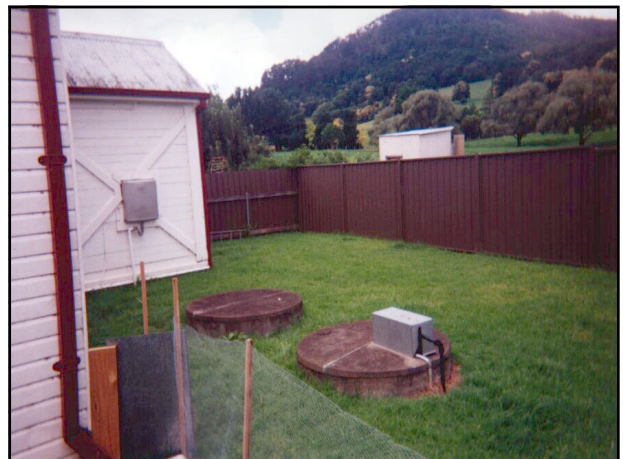
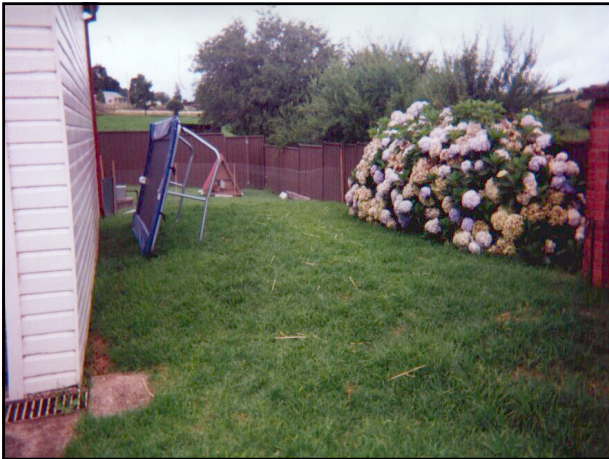
Scenario 3

- 500m² village block with 4 bedroom dwelling on reticulated water.
- Septic tank was undersized but in good condition and operating effectively.
- Effluent pumped to a raised ETA bed.
- ETA bed ~15m² in a high rainfall zone.

- What are some of your concerns about this system?
- The audit protocol in use found this system to be low risk. Do you agree?
- Do you think consideration of long-term, broad scale cumulative impacts would change this risk classification?

- You carry out a re-inspection of this system 12 months later. The ETA bed is constantly surcharging into the neighbouring property.
- What options would you consider acceptable for rectifying this system?
- What interim measures would you put in place to manage risk while a long-term option is implemented?

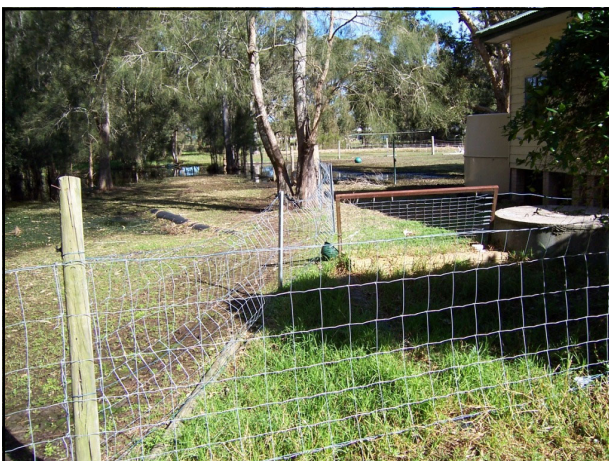
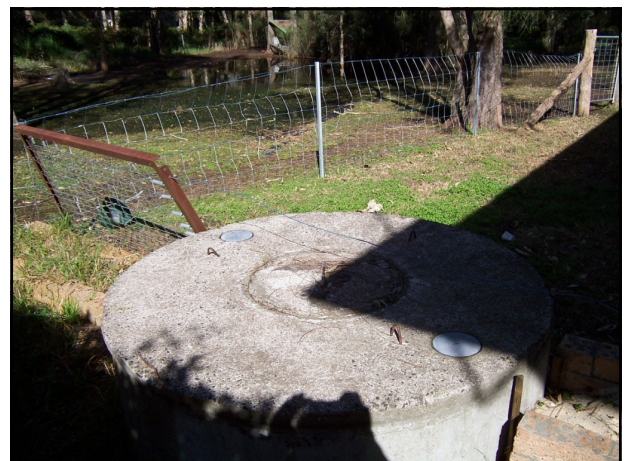
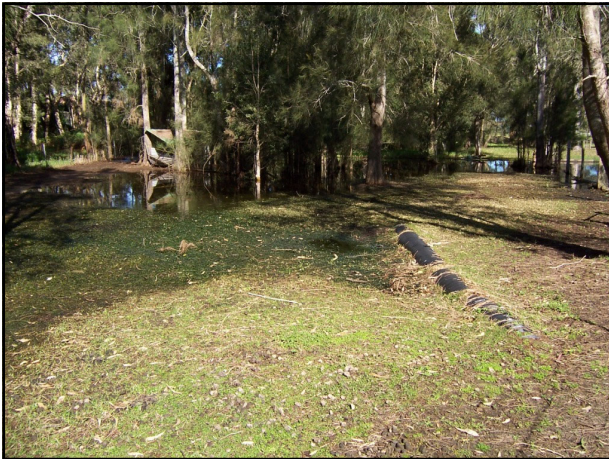
Scenario 4

- Three bedroom house (4 occupants) on tank water supply.
- Rural residential lot on a coastal floodplain (~4,000m²).
- Septic tank and gravity dosed absorption trench.

- List the reasons why you think this system is failing.
- Develop an appropriate strategy to rectify this system failure.

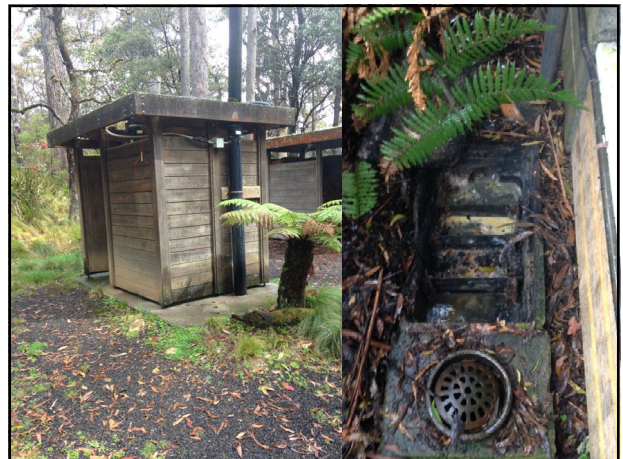
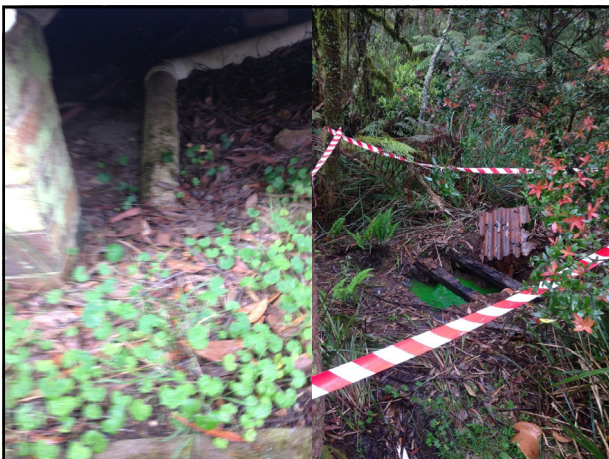
Scenario 5

- Pump-out toilet and greywater system at a State government-owned tourist accommodation
- Alpine area and National Park
- Variable occupancy
- Creek next to building
- Solar power – small battery system

- What are the priorities for the Site?
- What are the challenges of the Site?
- What treatment and land application options are suitable for this Site?

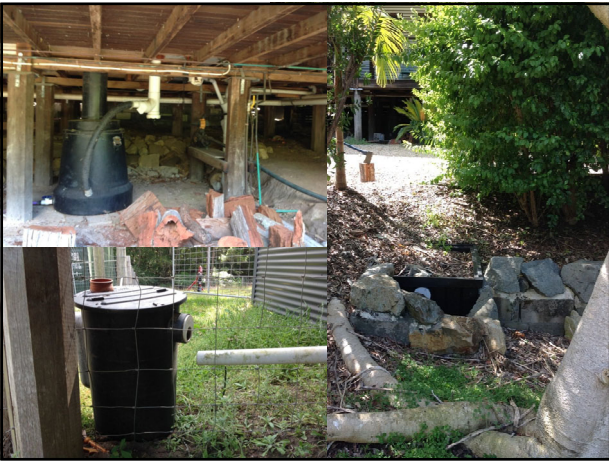
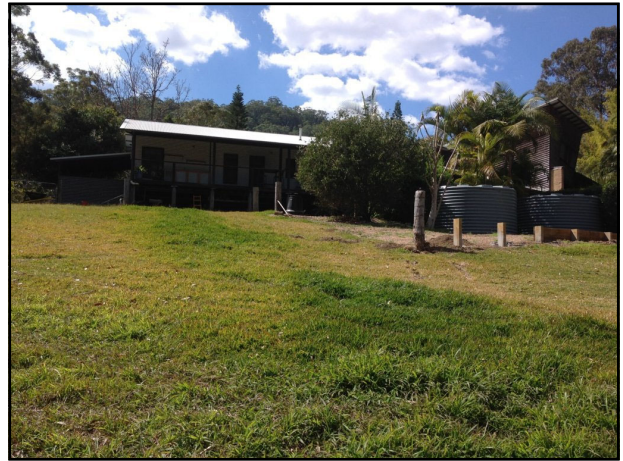
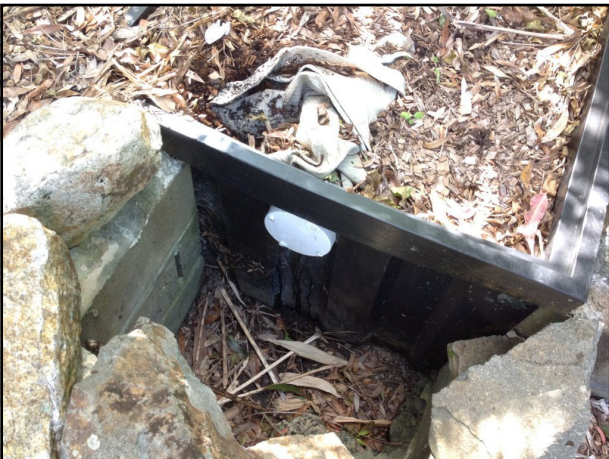
Scenario 6

- Composting toilet, grease trap and greywater diversion device
- Rural property
- Poor maintenance

- Challenges of this composting toilet style?
- What is potentially happening at the greywater filter?
- Why is the grease trap disconnected?
- What is the maintenance program for this system?
- Why is there a green grass down the slope instead of across the slope?
